**PROJECT SPECIFIC DESIGNATED SUBSTANCE REPORT  
CANADIAN FOOD INSPECTION AGENCY (CFIA)  
BACKFLOW PREVENTER PROJECT  
3851 FALLOWFIELD ROAD  
OTTAWA, ONTARIO**

**GEC PROJECT No. 33072  
February 6, 2023**

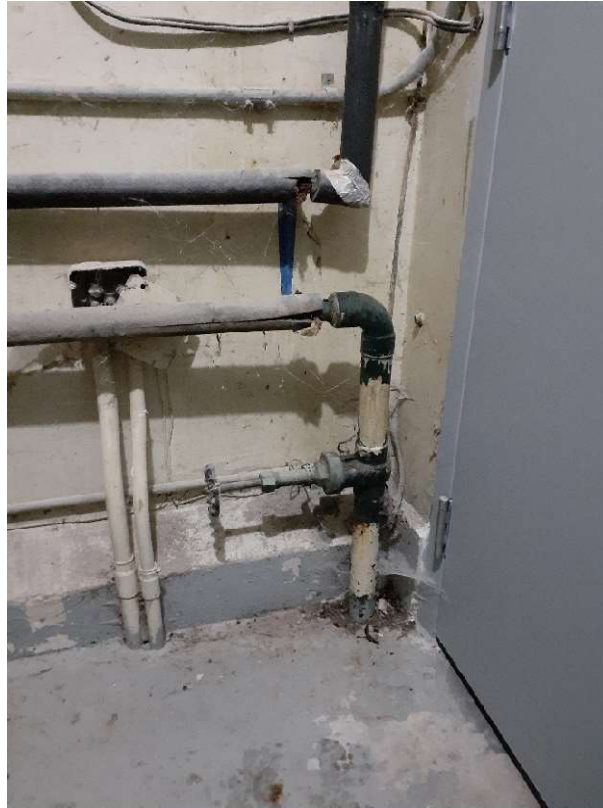
**Figure 1:** Representative photograph of the project area in the Mechanical Room in Building 128. **Grey paint** on the floor [Sample ID: 128-LP-01; 1,460 ppm lead] and **beige paint** on the wall [Sample ID: 128-LP-02; 1,010 ppm lead] confirmed to contain high levels of lead. Pipe insulation observed to be non asbestos containing foam.

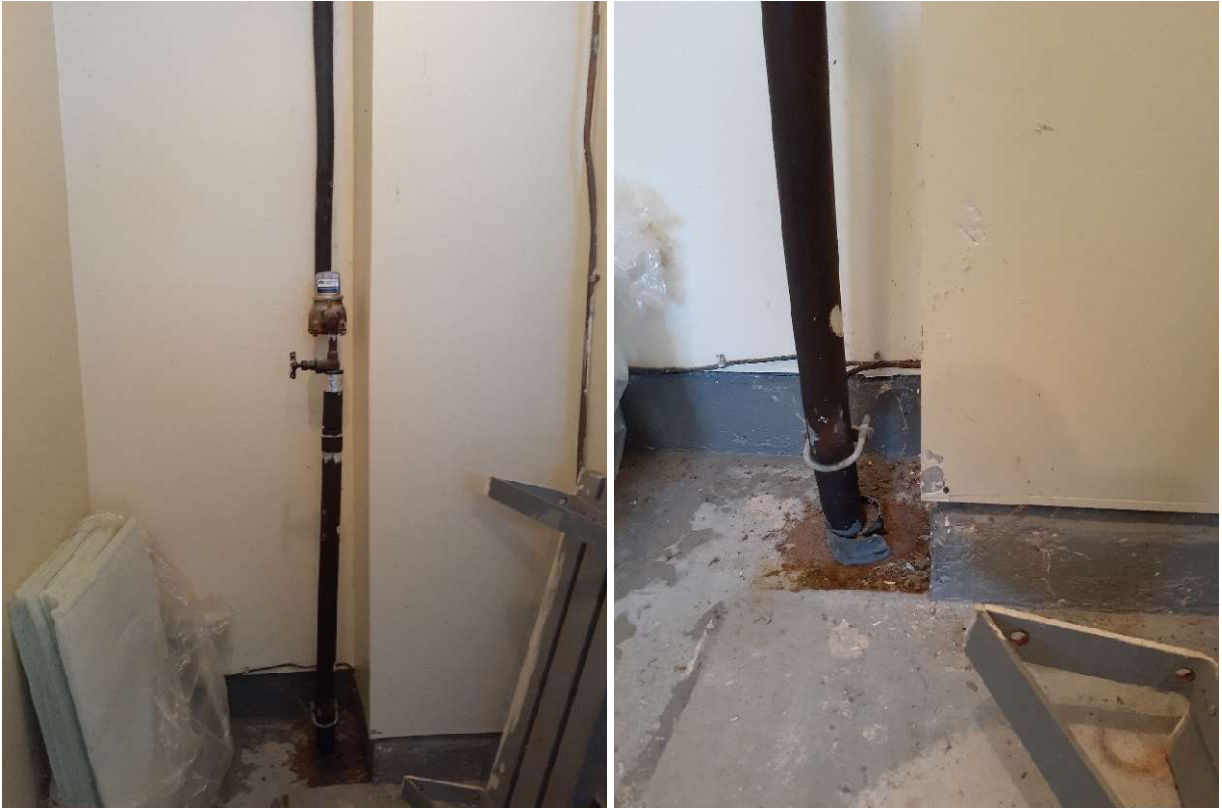
**Figure 2:** Representative photographs of the project area in the Mechanical Room in Building 129. Non-asbestos containing drywall joint compound located on the wall [Sample ID: 129-AS-01A-C]. **Grey paint** on the floor [**Sample ID: 129-LP-01; 458 ppm lead**] confirmed to contain higher levels of lead, and the beige paint on the wall [Sample ID: 129-LP-02; 6 ppm lead] contains low levels of lead.

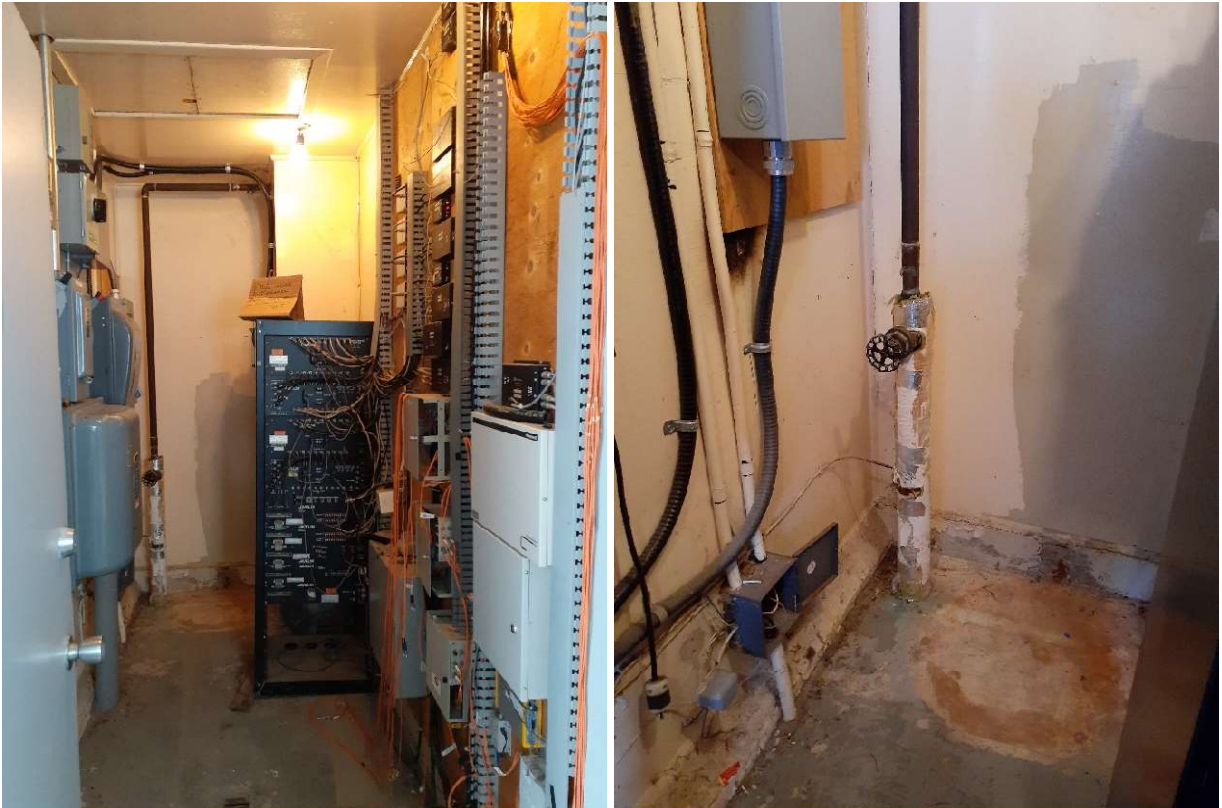
**Figure 3:** Representative photographs of the Mechanical Room in Building 130. **Grey paint on the floor [Sample ID: 130-LP-01; 569 ppm lead]** and **beige paint on the wall [Sample ID: 130-LP-02; 168 ppm lead]** confirmed to contain high levels of lead. Pipe insulation confirmed to be non asbestos containing fibreglass.

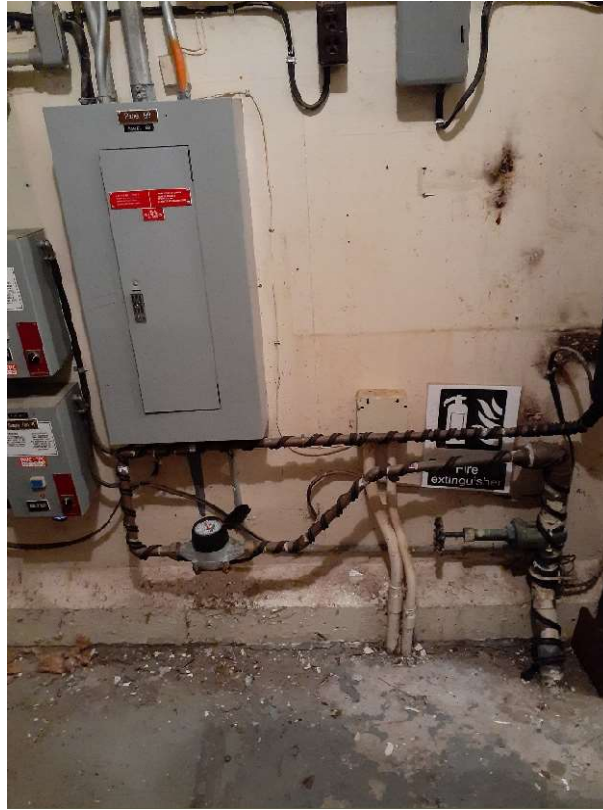
**Figure 4:** Representative photograph of the Mechanical Room in Building 138. Non-asbestos containing white caulking located at the seam between the floor and the wall [Sample ID: 138-AS-01A-C]. **White paint on the wall [Sample ID: 138-LP-01; 362 ppm lead]** and **grey paint on the floor [Sample ID: 138-LP-02; 2,320 ppm lead]** confirmed to contain high levels of lead.

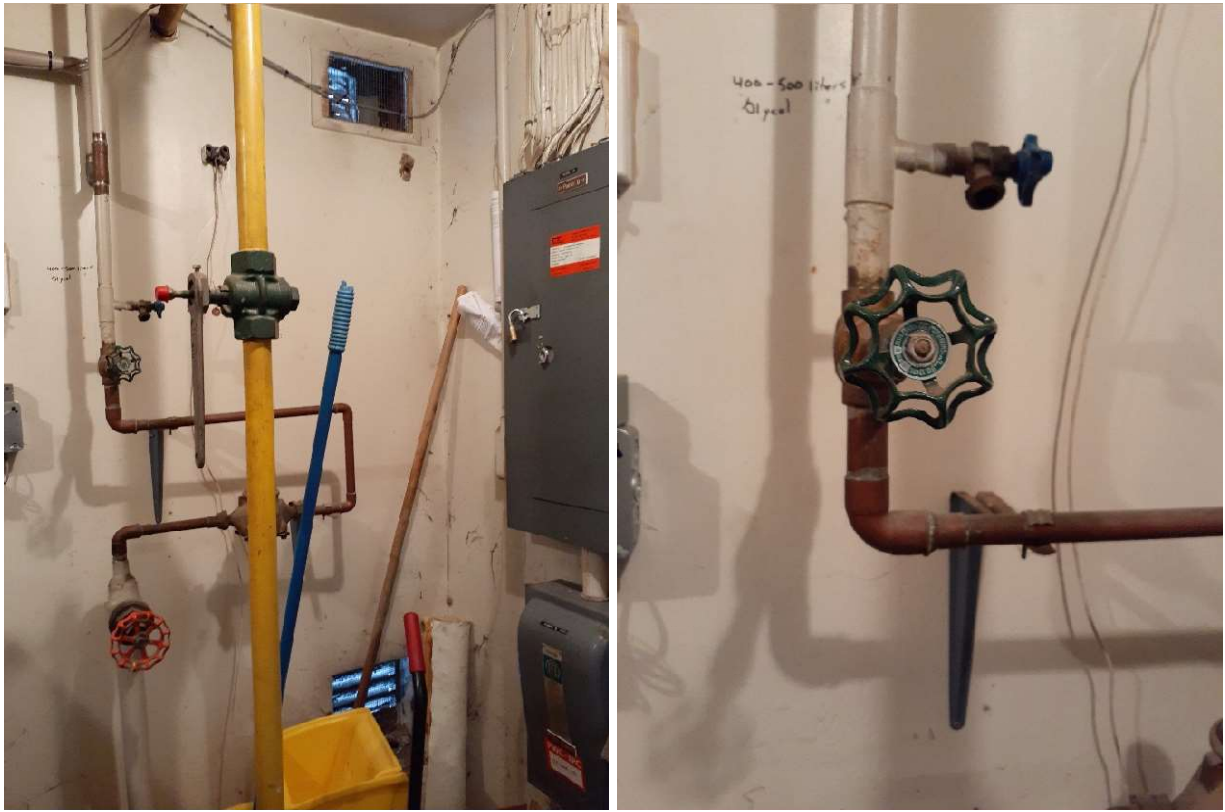
**Figure 5:** Representative photographs of the Mechanical Room in Building 141. Non-asbestos containing drywall joint compound located on the wall and ceiling [Sample ID: 141-AS-01A-C]. **White paint on the wall [Sample ID: 141-LP-01; 1,900 ppm lead]** confirmed to contain high levels of lead.

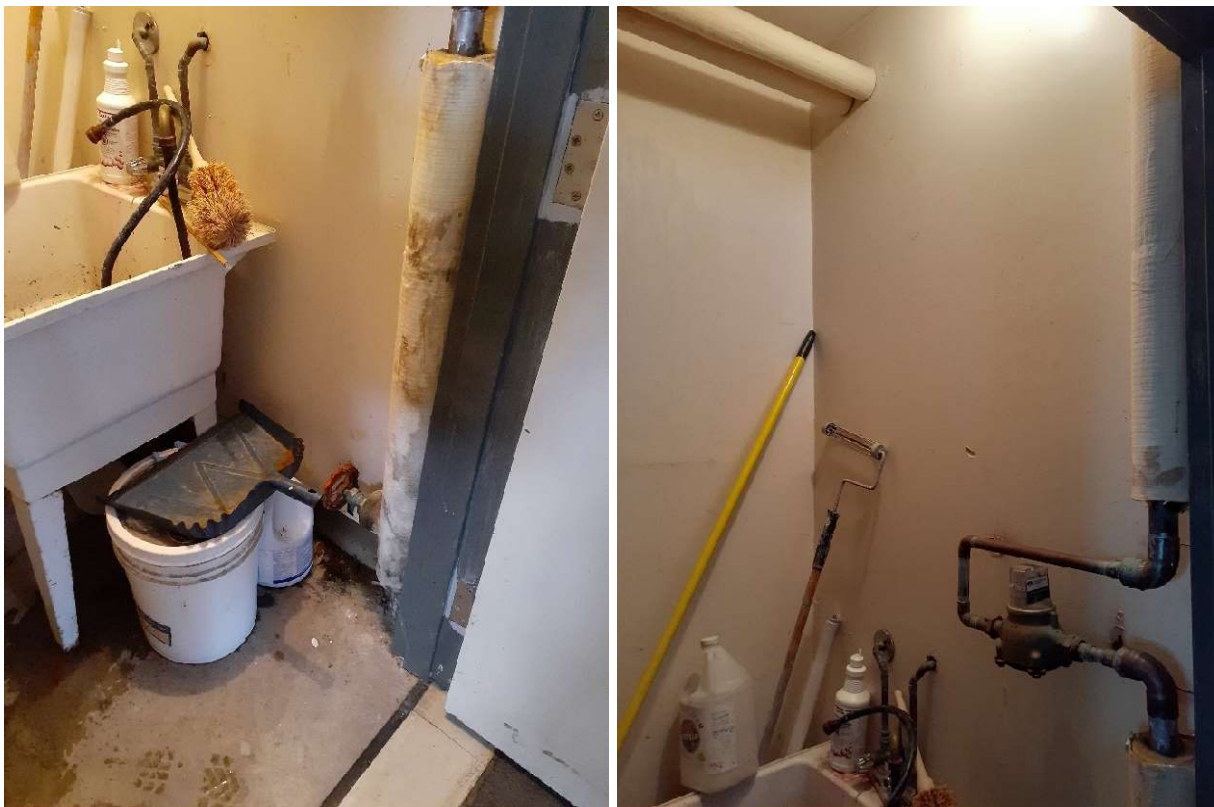
**Figure 6:** Representative photographs of the Mechanical Room in Building 142. Non-asbestos containing drywall joint compound located on the wall and ceiling [Sample ID: 142-AS-01A-C]. Beige paint on the wall [Sample ID: 142-LP-01; 8 ppm lead] contains low levels of lead. Pipe insulation confirmed to be non asbestos containing fibreglass. Suspected mould observed on the fibreglass pipe at the water entry.

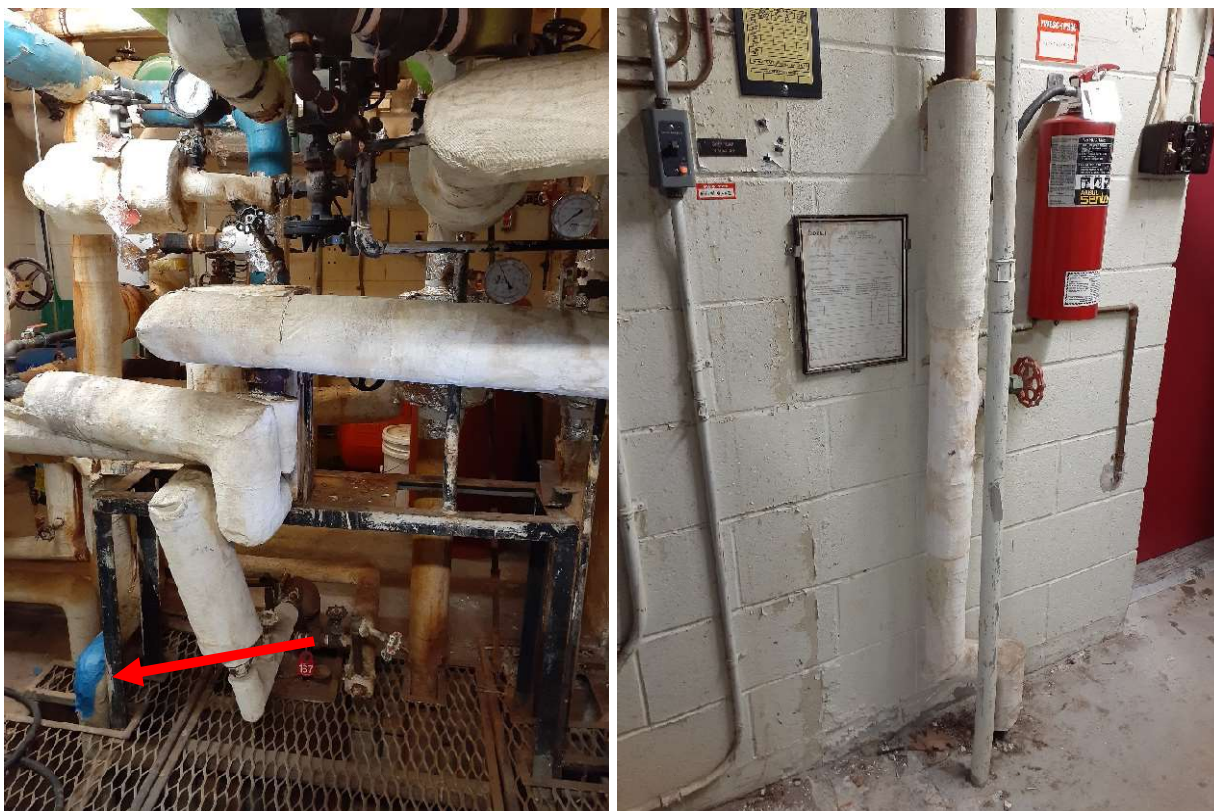
**Figure 7:** Representative photographs of the Mechanical Room in Building 158. Non-asbestos containing cement compound located on the pipe fitting [Sample ID: 158-AS-01A-C]. Only one fitting was tested as per client request. **Grey paint** on the floor [Sample ID: 158-LP-01; 1,270 ppm lead] confirmed to contain high levels of lead. Pipe insulation on the water entry pipe confirmed to be non asbestos containing fibreglass. No other pipe insulation was assessed as it is not anticipated to be disturbed as part of the backflow installation project.

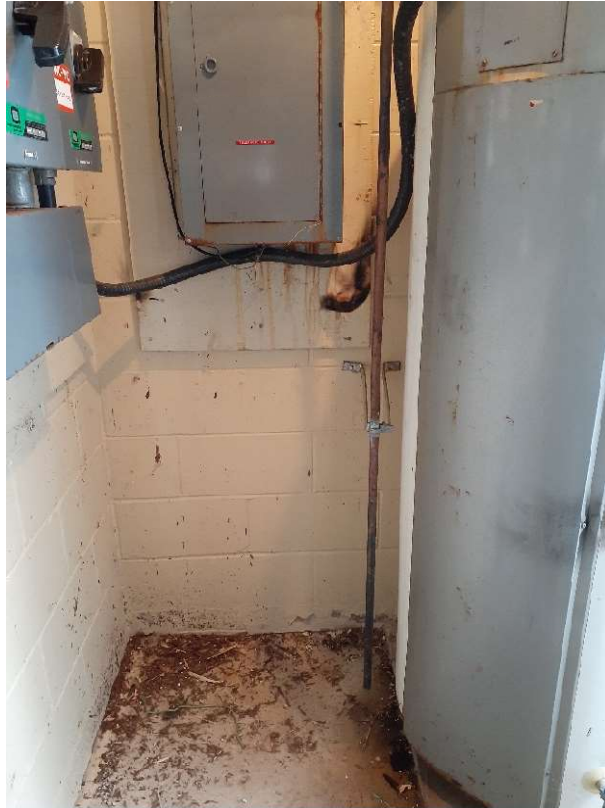
**Figure 8:** Representative photograph of the Mechanical Room in Building 169. Non-asbestos containing concrete block mortar located on the wall [Sample ID: 169-AS-01A-C]. Beige paint on the wall [Sample ID: 169-LP-01; 41 ppm lead] contains low levels of lead.

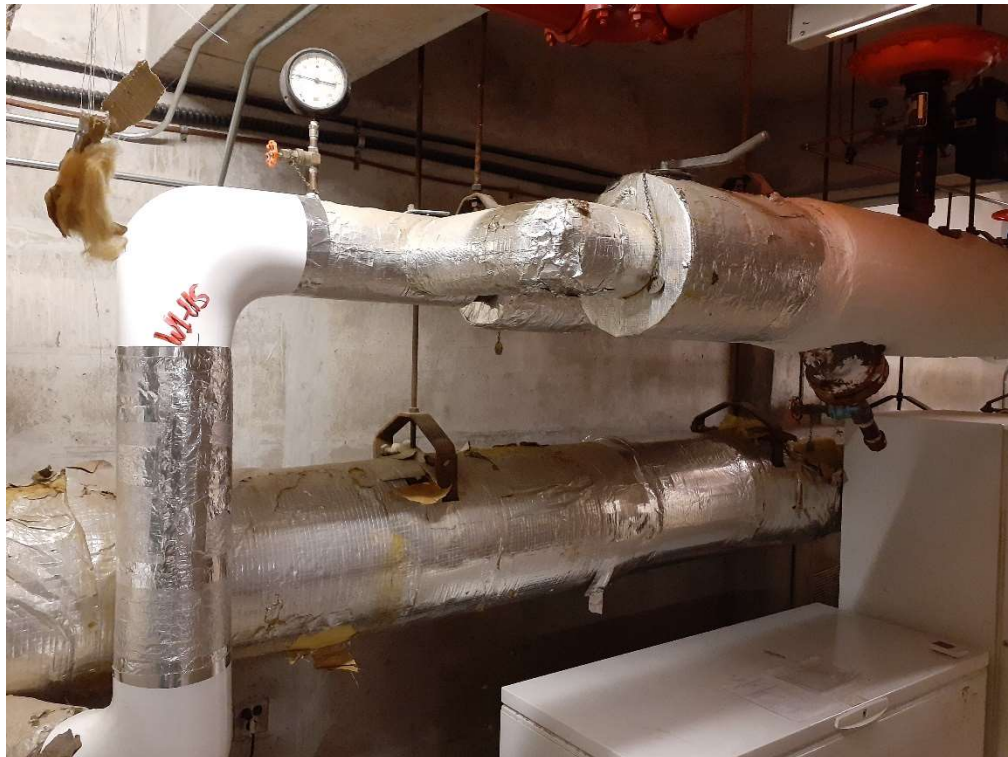
**Figure 9:** Representative photograph of the project area in the Mechanical Room in the C-Wing of Building 201. Tar paper under fibreglass insulation was confirmed to be non asbestos containing – 201-AS-01A-C.

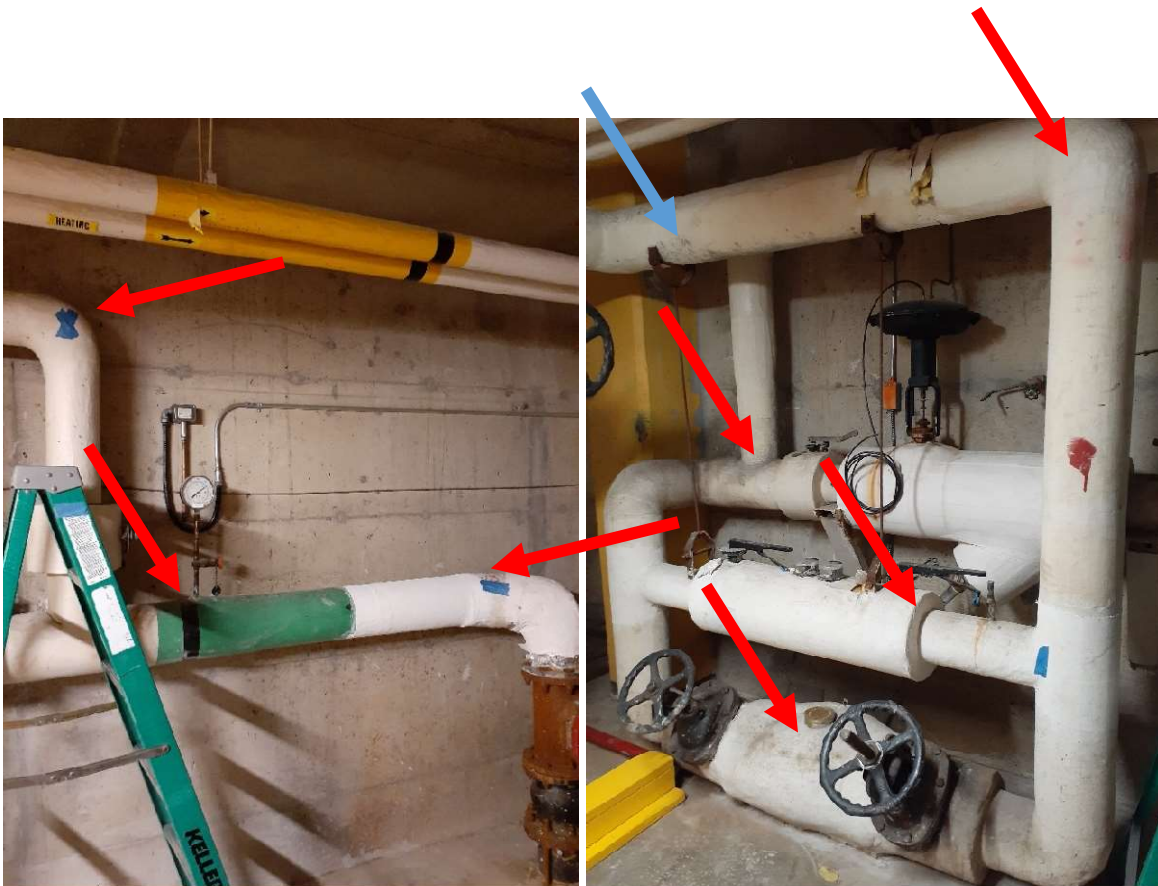
- **Grey cement compound [Sample ID: 201-AS-02A-C]** sampled from the pipe fittings and end caps in the A-Wing Mechanical Room of Building 201 was confirmed to contain **65% chrysotile asbestos**. The material was assessed to be in good condition and is present in nine (9) pipe fittings, and twelve (12) end caps in the project area.

**Figure 10:** Representative photograph of the project area in the Mechanical Room in the A-Wing of Building 201. Grey cement compound located on the pipe fitting and end caps confirmed to contain **65% chrysotile asbestos [Sample ID: 201-AS-02A-C]**. Suspect mould on pipe insulation (blue arrow).

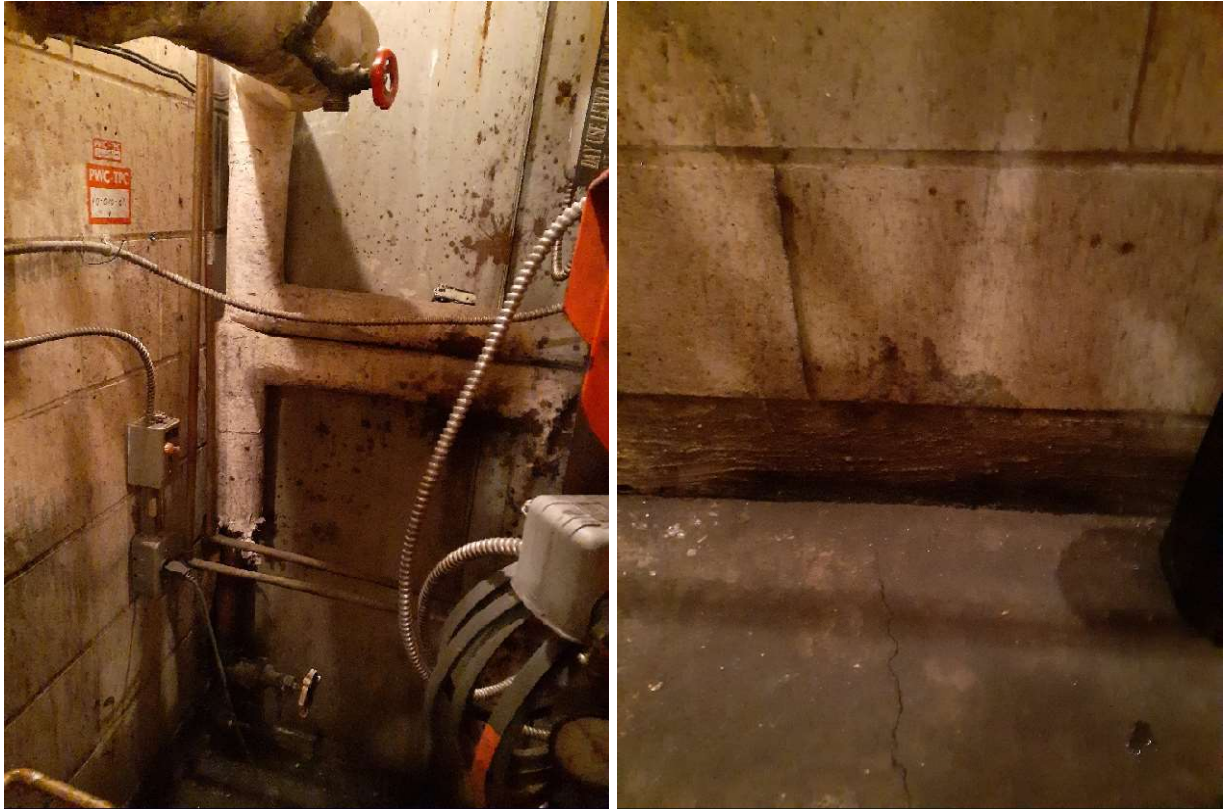
**Figure 11:** Representative photographs of the project area in Mechanical Room C in Building 206. Non-asbestos containing concrete block mortar located on the wall [Sample ID: 206-AS-01A-C]. **Grey paint** on the floor [Sample ID: 206-LP-01; **1,310 ppm lead**] confirmed to contain higher levels of lead, and the beige paint on the wall [Sample ID: 206-LP-02; 31 ppm lead] contains low levels of lead.

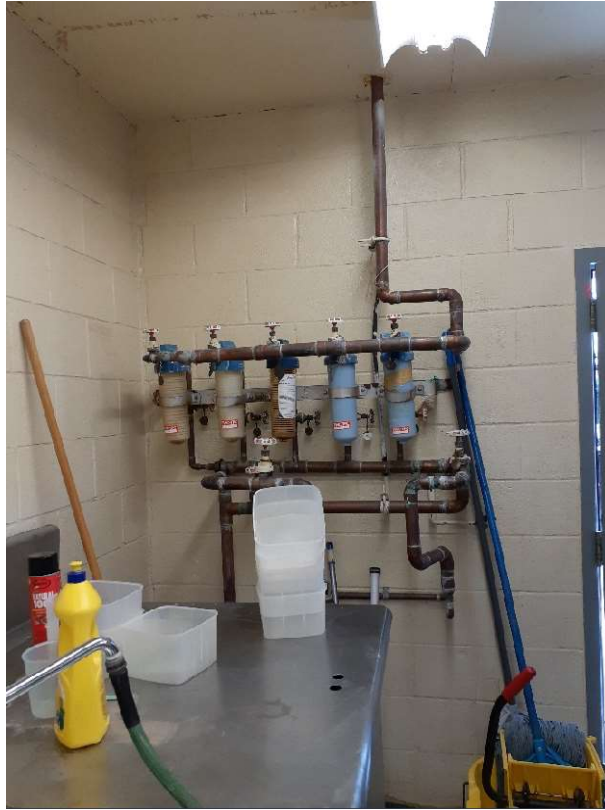
**Figure 12:** Representative photograph of the project area in the Seed Storage Room in Building 210. Non-asbestos containing concrete block mortar located on the wall [Sample ID: 210-AS-01A-C]. Beige paint on the wall [Sample ID: 210-LP-01; 12 ppm lead] contains low levels of lead.

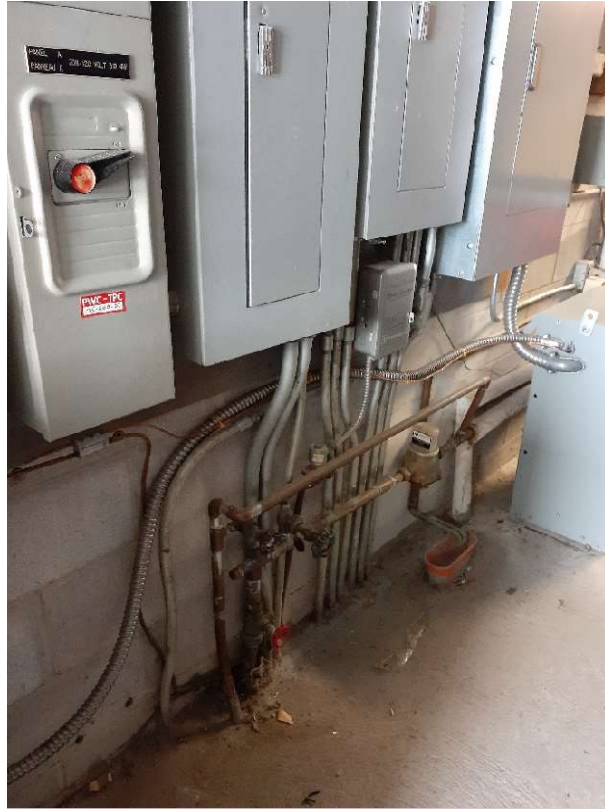
**Figure 13:** Representative photograph of the project area in the Mechanical Room in Building 211. **Grey paint** on the floor [Sample ID: 211-LP-01; 2,250 ppm lead] confirmed to contain high levels of lead.

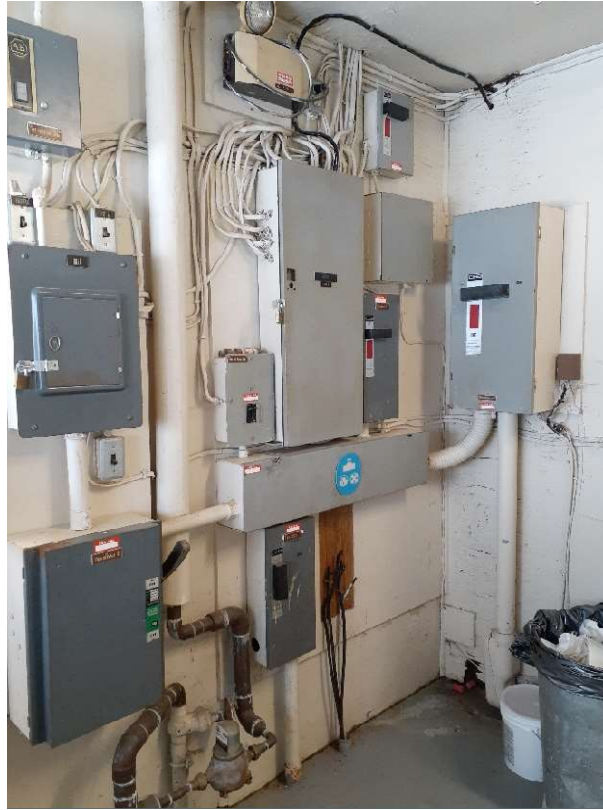
**Figure 14:** Representative photograph of the project area in the Office Space of Building 220. **Grey paint** on the floor [**Sample ID: 220-LP-02; 566 ppm lead**] confirmed to contain higher levels of lead, and the beige paint on the wall [Sample ID: 220-LP-01; 8 ppm lead] contains low levels of lead.

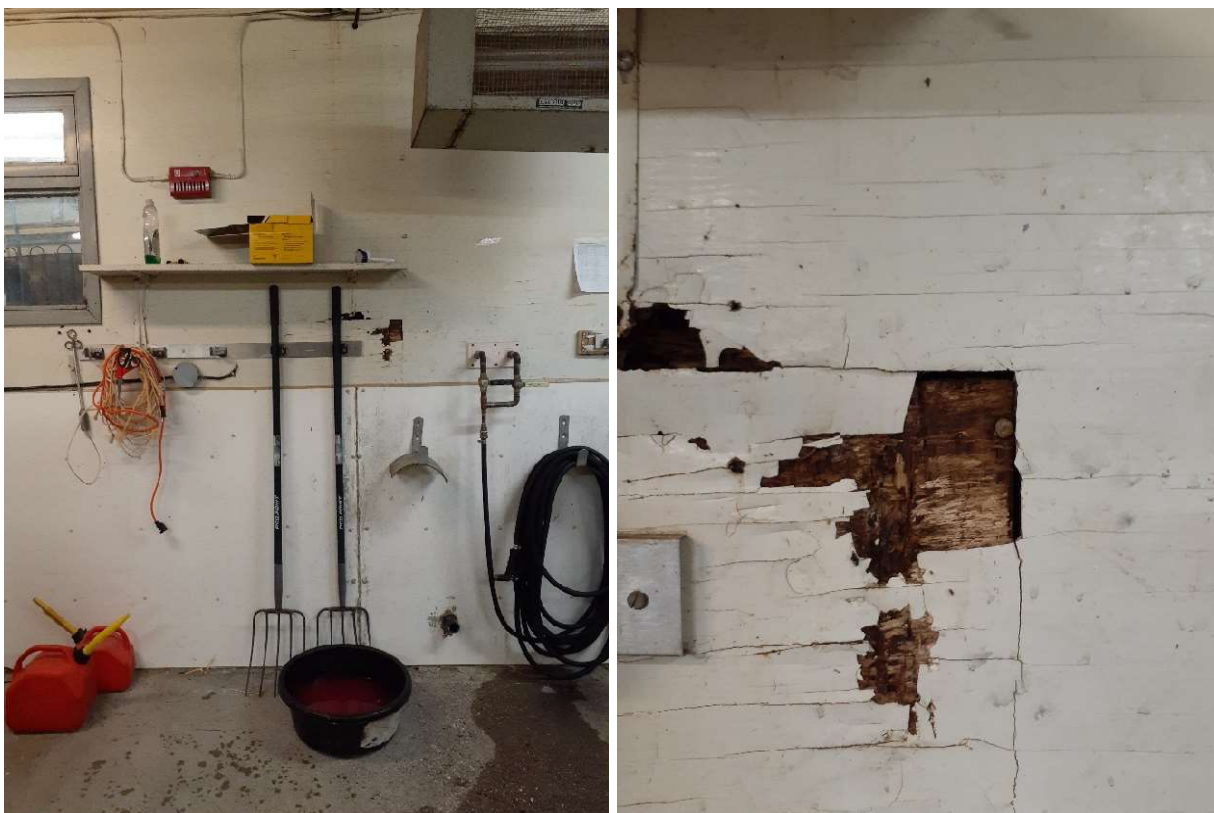
**Figure 15:** Representative photograph of the Animal Room in Building 220. Non-asbestos containing white skim coating located on the wall, see photo on the right [Sample ID: 220-AS-01A-C].

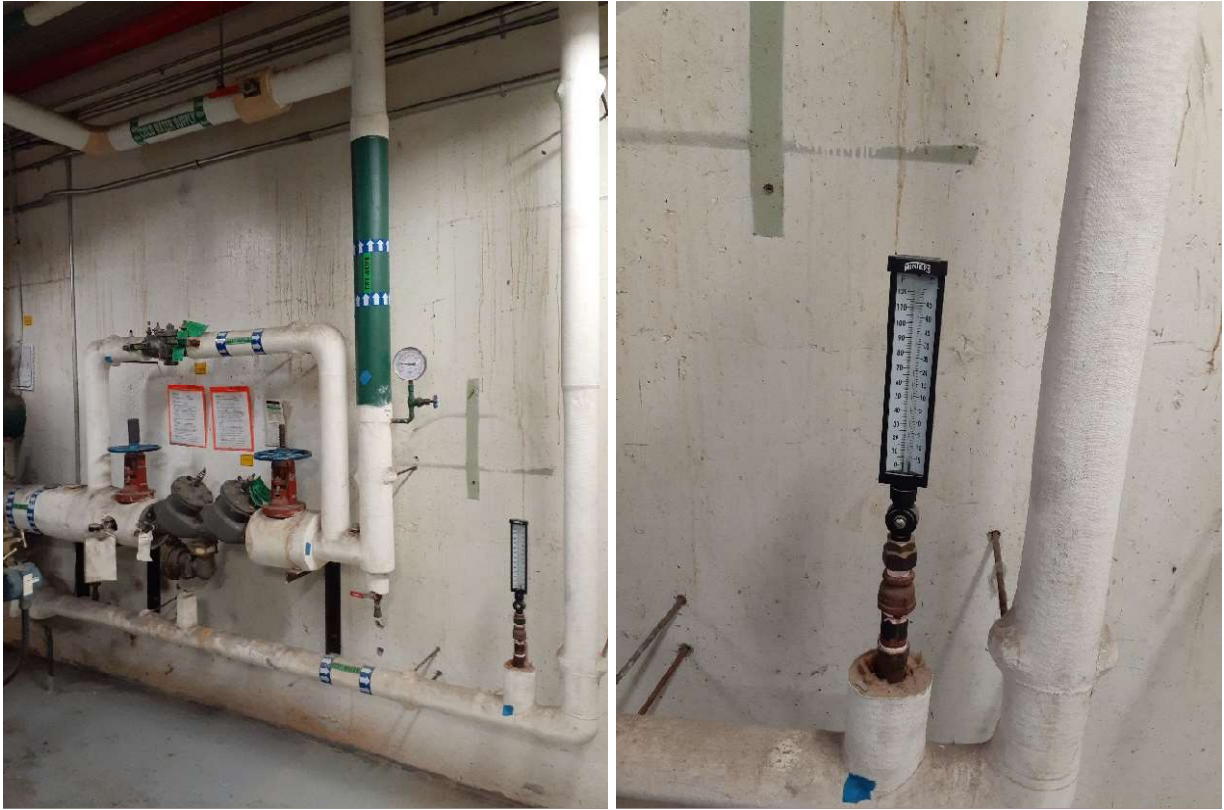
**Figure 16:** Representative photograph of the project area in the Mechanical Room of the Central Heating Plant. **White paint** on the wall [Sample ID: CHP-LP-02; 1,200 ppm lead] confirmed to contain higher levels of lead, and the grey paint on the floor [Sample ID: CHP-LP-01; 74 ppm lead] contains low levels of lead. Thermometer suspected to contain **mercury**. Pipe insulation in the project area confirmed to be non asbestos containing.
