**ENHANCED PHASE 1
ENVIRONMENTAL SITE ASSESSMENT
CANADIAN COAST GUARD NAVIGATIONAL AID
L.L. 488.0
BRIGHTON REAR RANGE
BRIGHTON, ONTARIO**

March 6, 2001

XCG File #1-336-63-01

**PHASE 3
ENVIRONMENTAL SITE ASSESSMENT
CANADIAN COAST GUARD LIGHT STATION
L.L. 488.0 BRIGHTON REAR RANGE
BRIGHTON, ONTARIO
Presqu'île Bay, Lake Ontario**

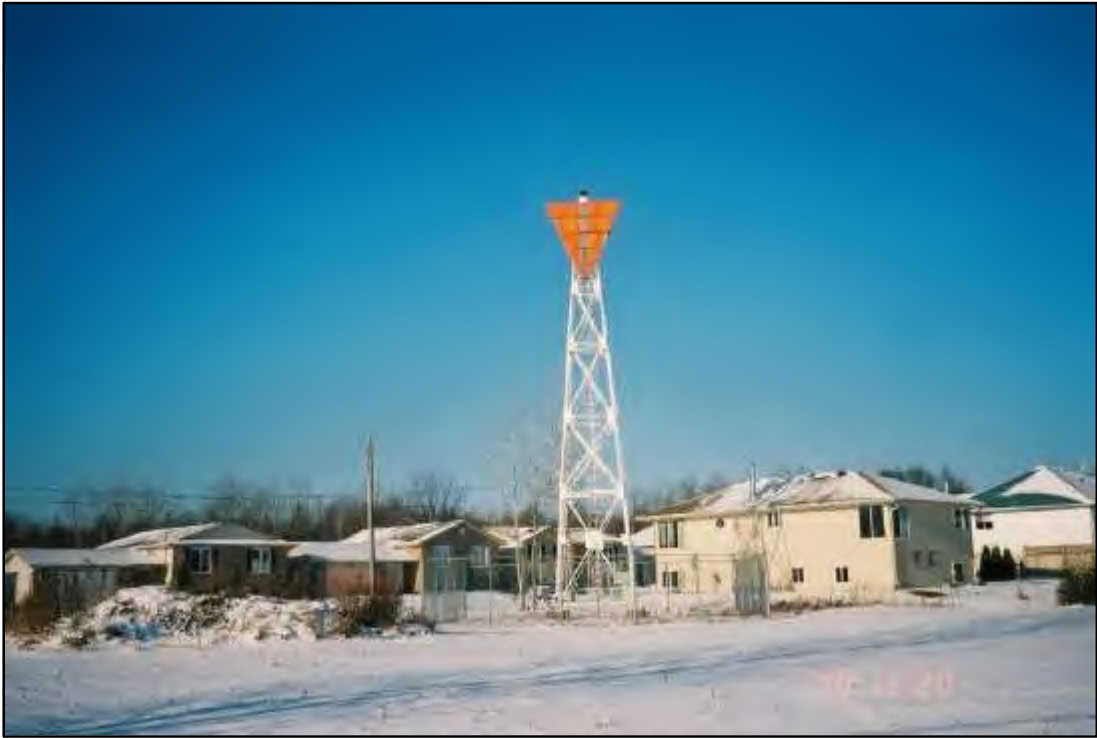
Photo 1. Brighton Rear Range Navigation Aid. View facing north.

| STRUCTURE | LOCATION | WATER ¹ | DESCRIPTION/CONDITION | DATE |
|---|---|---|---|---|
| 1 Skeleton Tower | Centre of property | 50 m | The steel skeleton tower is painted white with a fluorescent orange triangular daymarker with a vertical black stripe. The structure is built upon four concrete footings. The structure appears to be in good condition. | 1950's or 1960's |

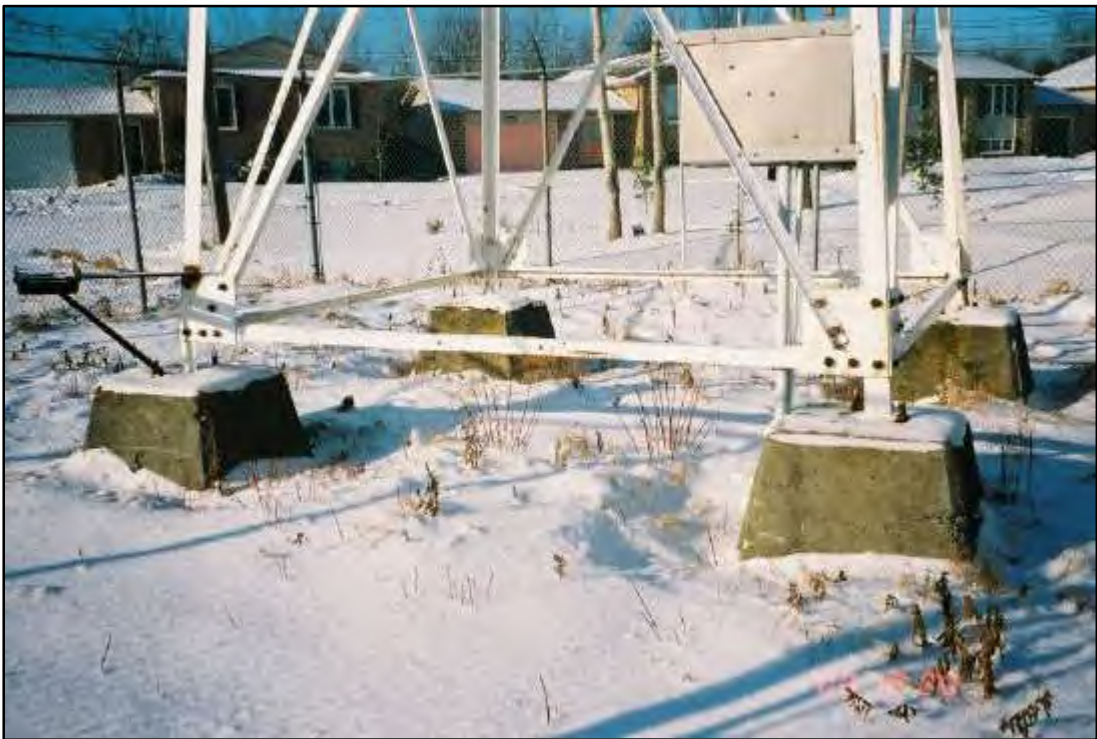
Photo 2. Base of Navigation Aid within fenced area.

| .3 | LEAD | Y | The skeleton tower was installed before 1976 and lead-based paint has been confirmed to be present (see Table 3). A typical white paint sample was submitted from the Navigational Aid at Brighton Rear Range and was found to contain 22,800 ppm lead. This sample exceeds the 5,000 ppm limit. Estimates of the quantity of lead paint at this site are provided in the sample log included in Appendix C. |

The presence of lead in painted surfaces (at concentrations above 0.5%) of Brighton Rear Range site has been confirmed from analytical results from this Navigational Aid site. Some evidence of “flaking” paint was noted on the surfaces of the Navigational Aid. The presence of lead in paint is primarily a concern if the paint is disturbed by sanding during building renovations or during demolition activities or if the structure, or part thereof, is used or inhabited by pre-school children. Under provincial regulations, the only requirement for further action is specified by the *Occupational Health and Safety Act*, which requires that contractors be notified of the presence of lead (and other designated substances) in a building at the tendering stage so that appropriate measures can be taken by the contractor to protect workers from excessive exposure. The presence of metals in paint has also likely contributed to elevated levels of metals in surficial soils in the vicinity of the buildings at this site.

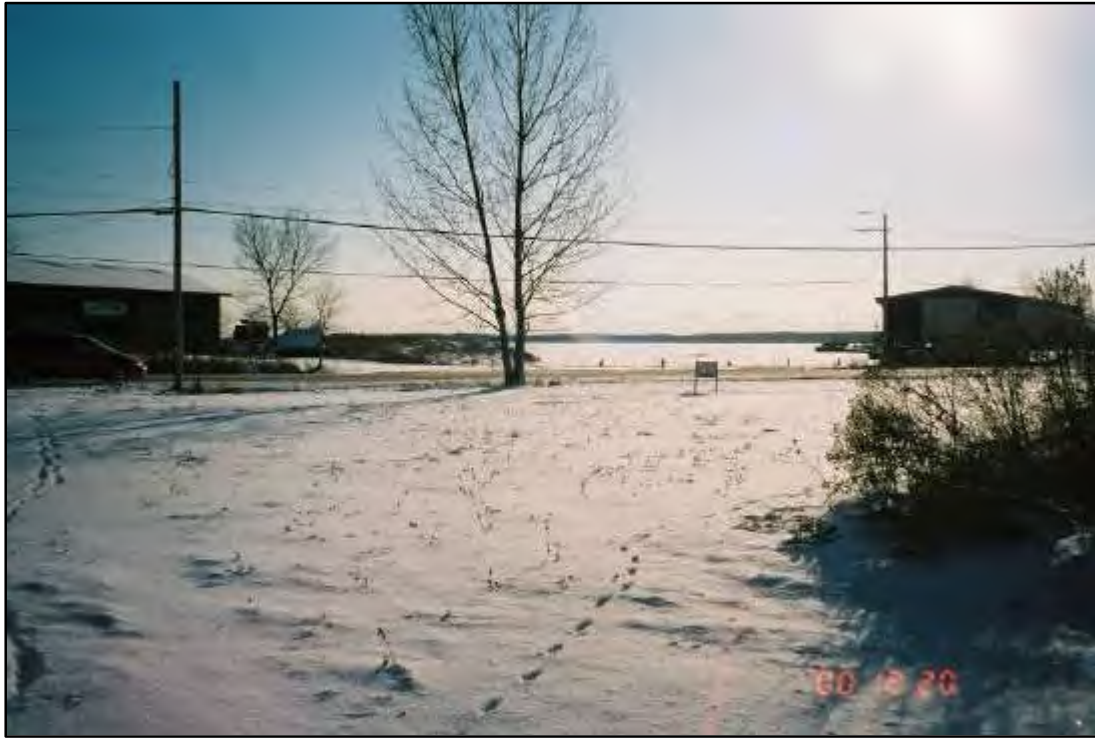
Photo 3. Presqu'ile Bay is viewed from the Navigation Aid facing south. Fill pile is evident on right side of photo.

| .11 | NON-HAZARDOUS DEBRIS | Y | A fill pile, probably relocated soil from development of the surrounding subdivision, is located approximately 3 metres southwest of the subject site. No other non-hazardous debris was observed near the structure. The fill pile has an approximate volume of 20 to 25 cubic metres, based on visual observation. |

A fill pile, possibly relocated soil from development of the surrounding subdivision, is located approximately 3 metres southwest of the subject site. No other non-hazardous debris was observed near the structure. The fill pile has an approximate volume of 20 to 25 cubic metres, based on visual observation.

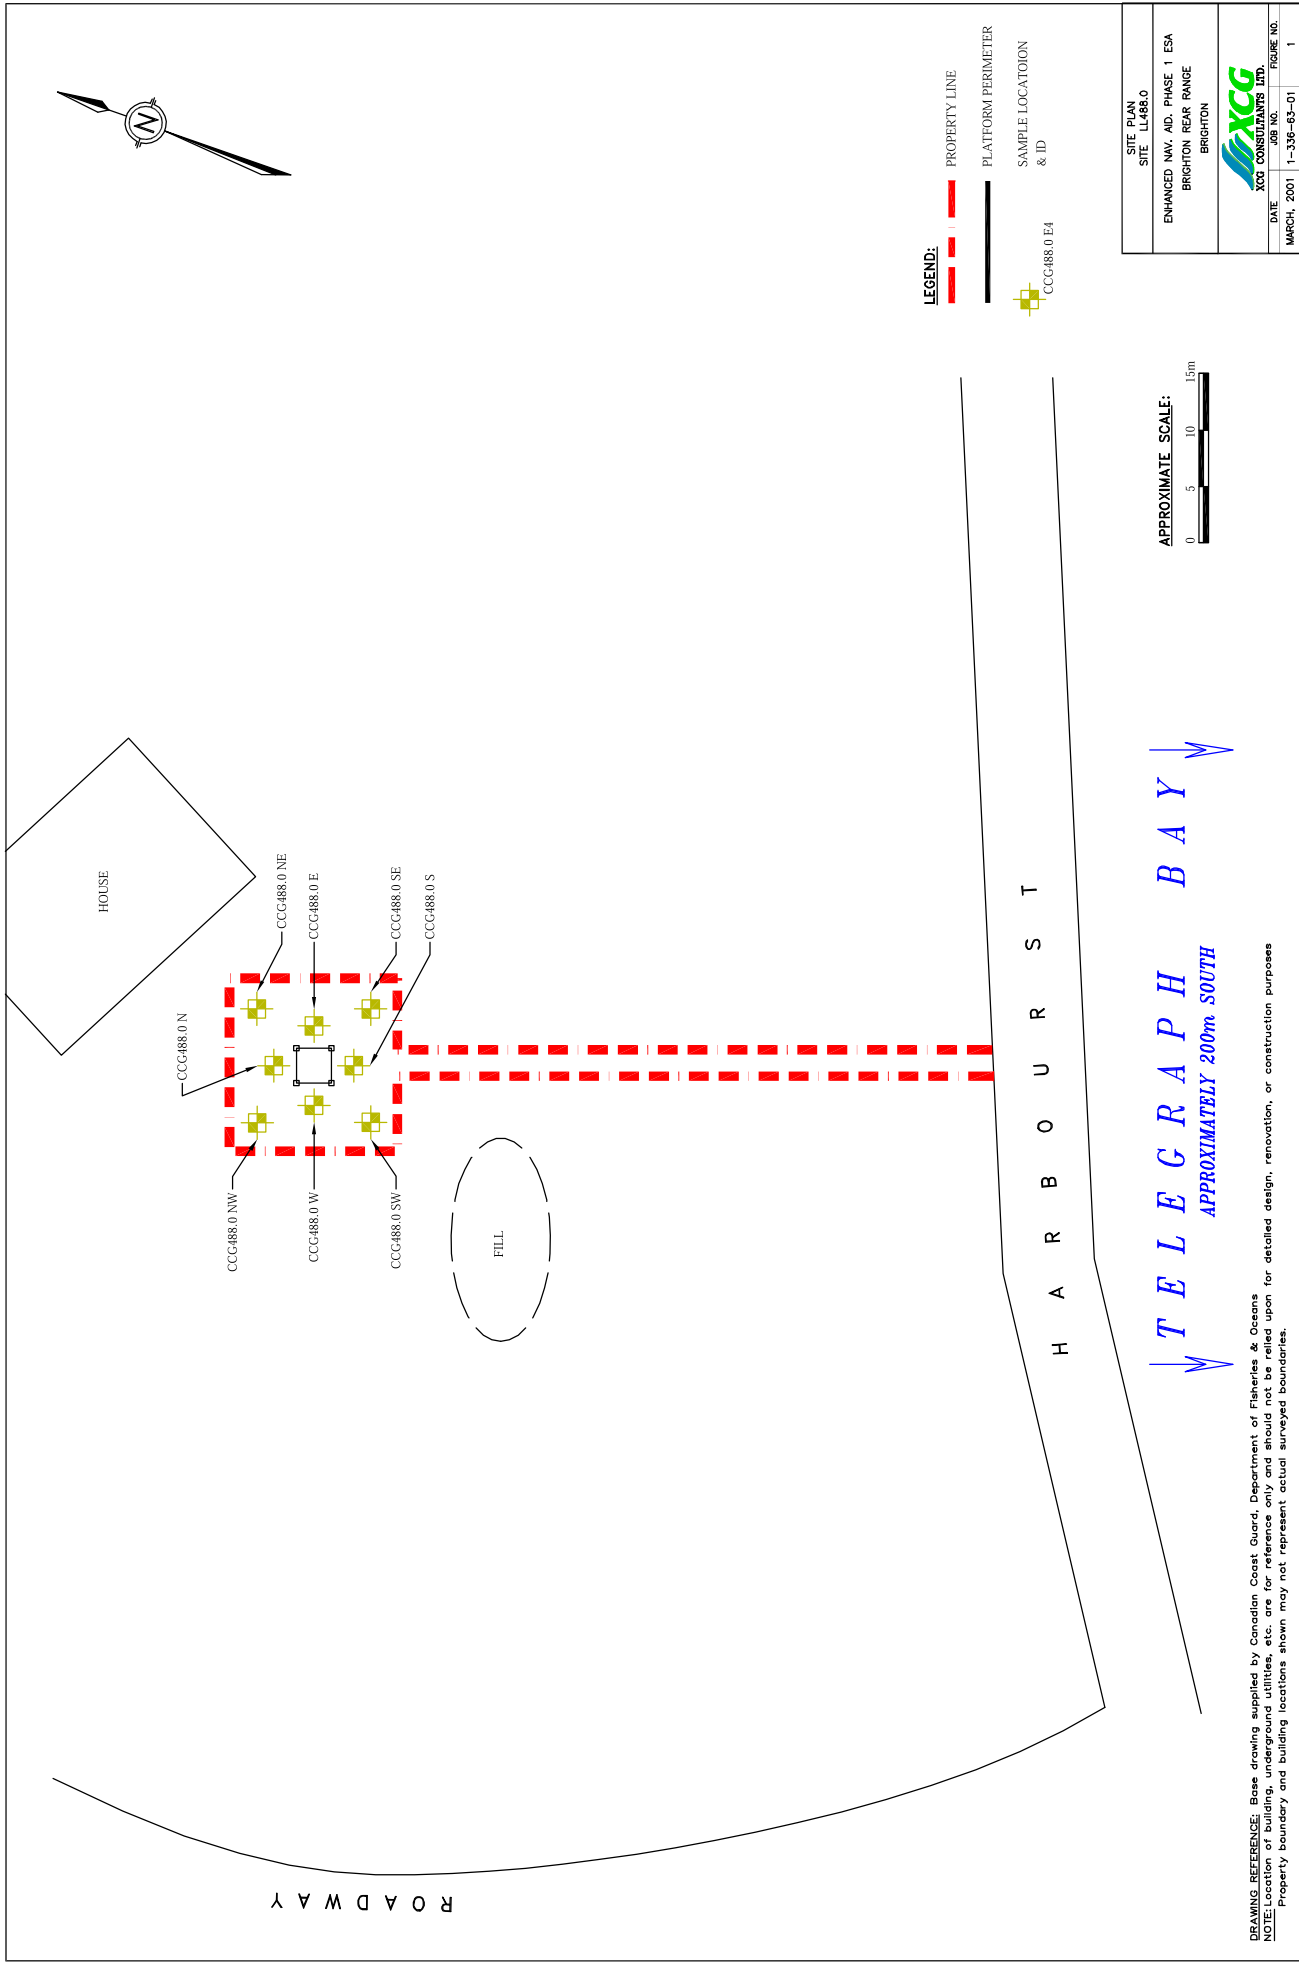
Figure 1 (Site Plan)
Figure 2 (Site Location Plan)
Topographical Map
Aerial Photographs

LEGEND:
 - - - - - PROPERTY LINE
 _____ PLATFORM PERIMETER
 [Green Square] SAMPLE LOCATION & ID
 [Green Square] CCC488.0 E4

The quantitative estimate of impacted soil on the subject site ranges between 12 and 120 cubic metres. Since this estimate is based on seven (including one duplicate) samples only, it is recommended that a Phase 2 subsurface sampling program be implemented to further delineate the contamination present on the site at the Brighton Rear Range Navigation Aid.
