Soils at the site are predominantly clay below the thin organic layer to 1.5 m below surface. However, many lenses occur within the upper 1 m below surface. The following is from a 2021 Geotech investigation.

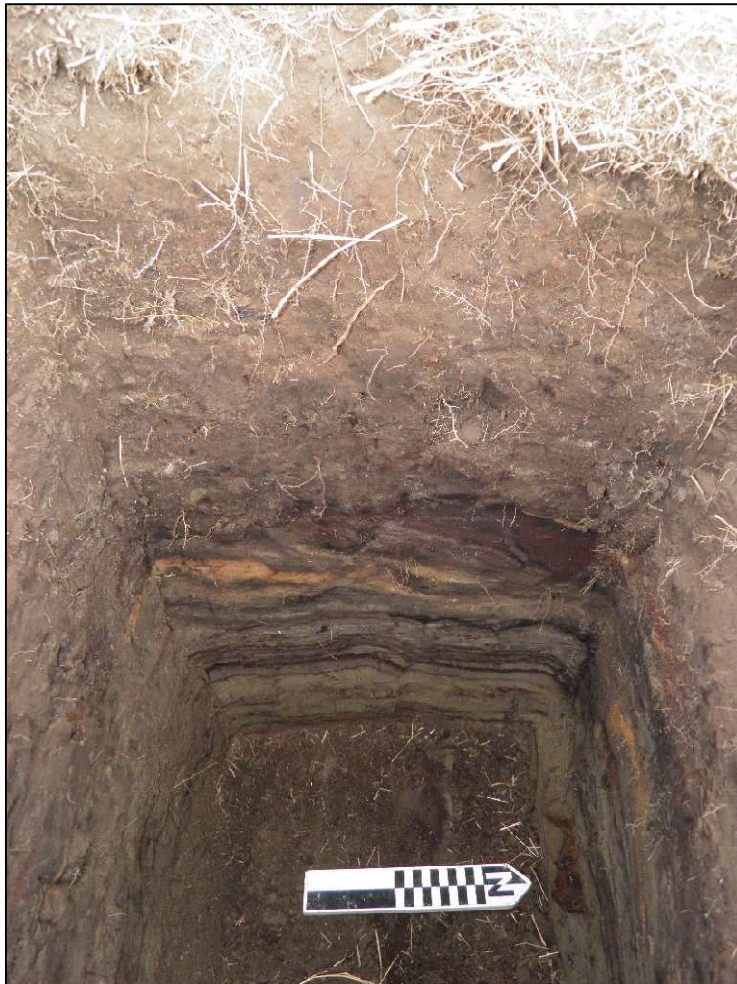
Soil profile in test unit. Upper layer may be a plough zone, but intact layers occur beneath.
